**INSPECTION OF ABDUL MANAN SECONDARY SCHOOL
CONSTRUCTION PROJECT IN KAPISA PROVINCE:
INSUFFICIENT PLANNING, SAFETY PROBLEMS, AND POOR
QUALITY CONTROL AFFECT PROJECT RESULTS**

SUBJECT: SIGAR Inspection Report 10-2: Inspection of Abdul Manan Secondary School Construction Project in Kapisa Province: Insufficient Planning, Safety Problems, and Poor Quality Control Affect Project Results

Summary of Report: SIGAR Inspection 10-2 October 26, 2009 Inspection of Abdul Manan Secondary School Construction Project in Kapisa Province: Insufficient Planning, Safety Problems, and Poor Quality Control Affect Project Results

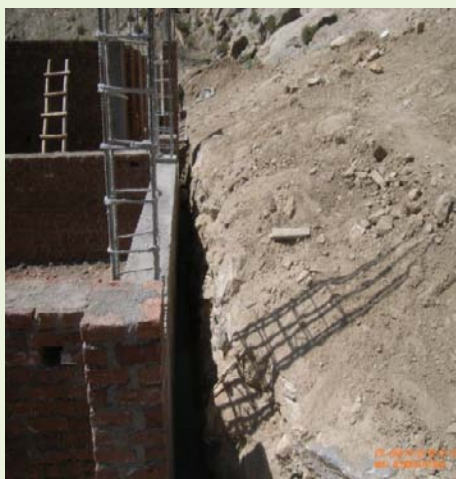
The photo at left shows the rear wall of the school structure constructed adjacent to the vertical wall of the excavation, leaving no room for the security perimeter wall. Contrary to accepted construction practices, the contractor was forced to excavate the area around the wall after it was built.

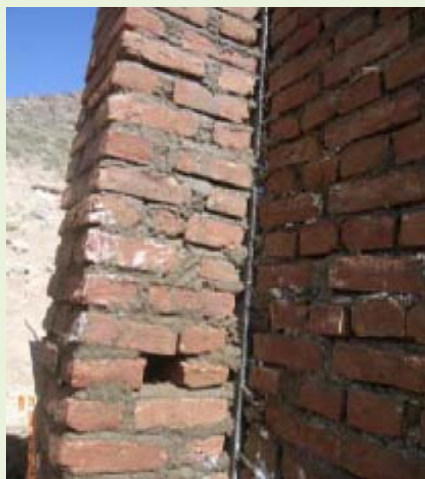
The photo at the right is an example of substandard masonry work which had to be demolished and rebuilt. (Photos provided by SIGAR)

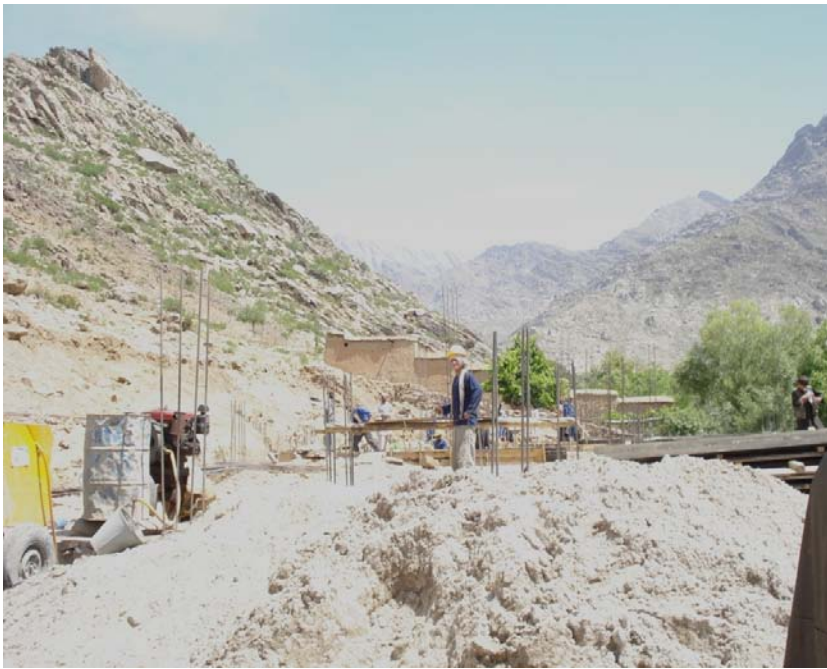
Site Photo 1: View of the challenging terrain where the Abdul Manan School is being constructed. Extensive grading work was required at this site prior to construction. (Photo provided by SIGAR)

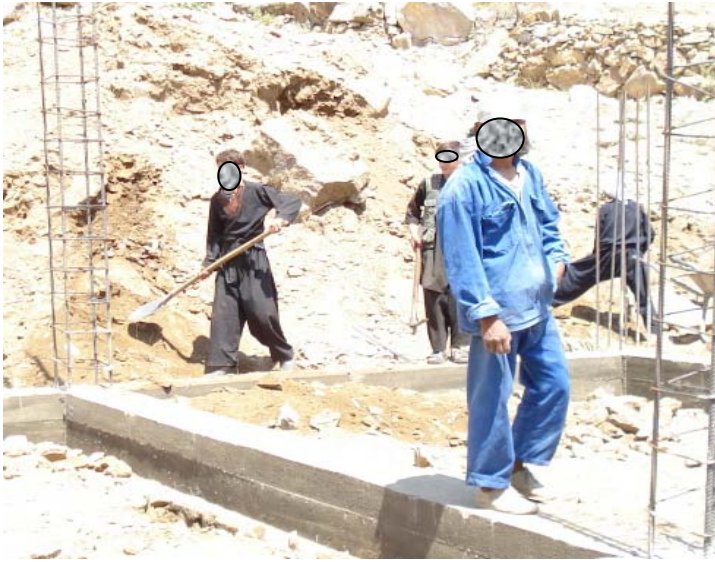
SIGAR also found that although the contractor made extensive mention of safety requirements for his workers in the project work plan, numerous safety violations were noted by SIGAR. These violations included workers without head, eye, hand, or foot protection. (See Site Photo 2)

Site Photo 2: Laborers working on the project with no personal protective equipment such as hardhats, gloves or, in some cases, even shoes. (Photo provided by SIGAR)

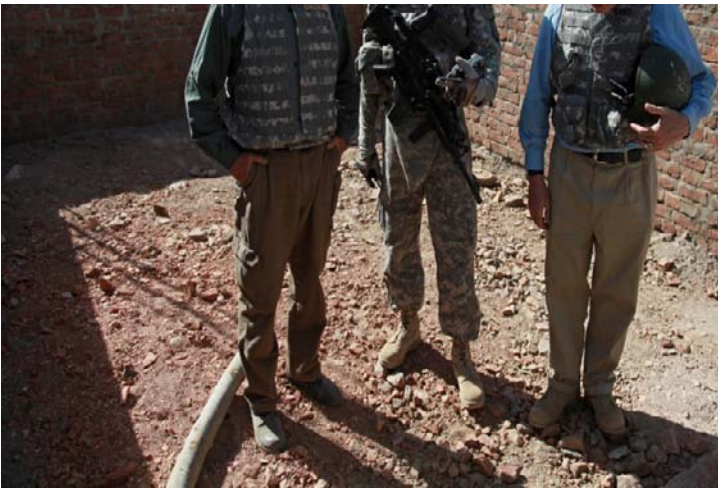
Site Photo 3: View of SIGAR inspectors with the PRT Quality Assurance Representative examining completed work. SIGAR found that the floor of the room had not been compacted to prepare it for the concrete slab-on-grade. (Photo provided by SIGAR)

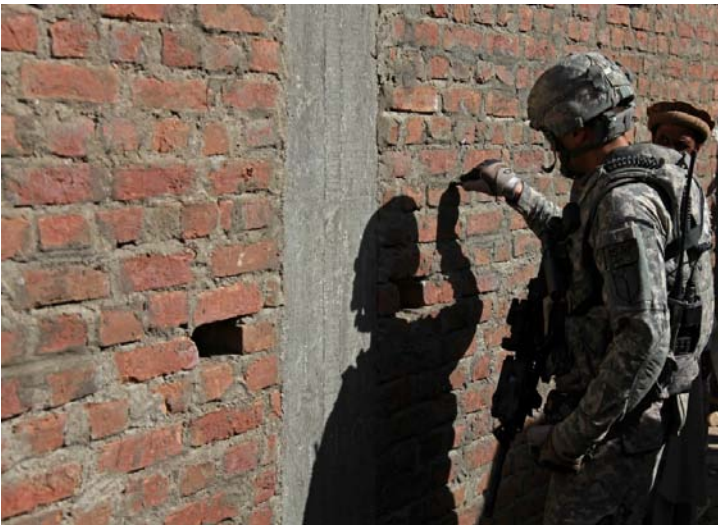
Site Photo 4: View of PRT Quality Assurance Representative testing the mortar work for durability. Such testing is critical to assess if the materials used meet the standards specified in the statement of work. In the case that materials do not meet these standards, the Quality Assurance Representative can order the contractor to redo the work which might involve tearing down already constructed sections of the project. (Photo provided by SIGAR)

This lack of quality control documentation was reflected by a lack of consistent performance and construction methods that had to be corrected late in the project life cycle. Examples include the contractor stating he was ready to pour concrete into the floors of rooms that had not yet been properly compacted (see Site Photo 3) and the PRT Quality Assurance representative having to direct several portions of completed brick work to be demolished due to use of improper mortar mixture in their construction (see Site Photo 4).
